# **DAM INSPECTION CHECKLIST** **POSSUM POINT POWER STATION** **POND ABC**

INSPECTION DATE: 3/31/15 1017 hrs.

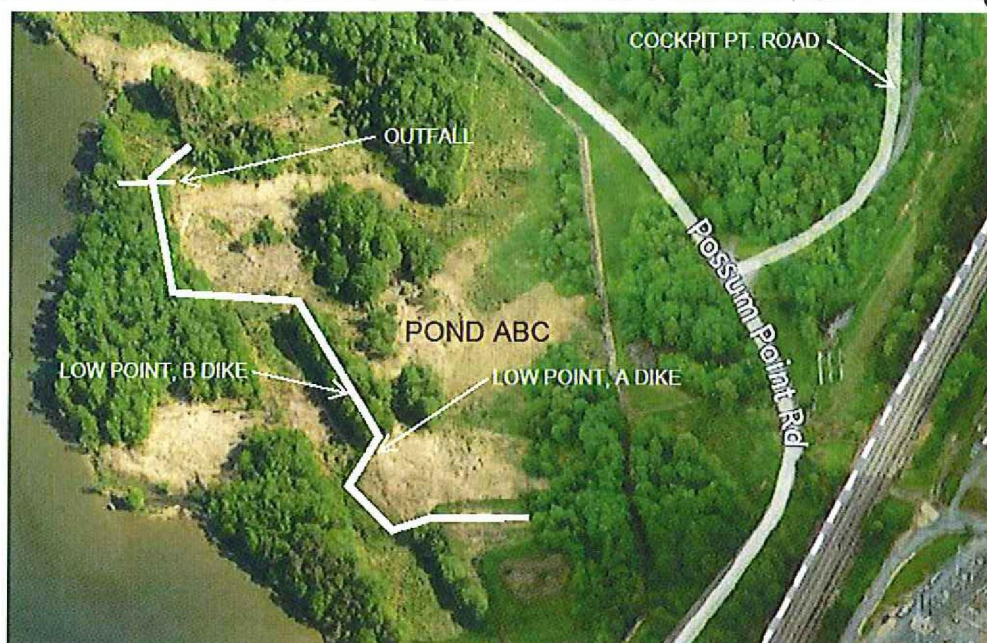
Location/ Condition	(y/n)	Change (y/n)	Comments
Low Point, A dike*			
Flow	Y*	Y*	1017 hrs. Standing water at perimeter of pond along road.
Erosion	N	N	8" deep standing water behind sandbags. Audible flow heard below rip rap.
Low Point, B dike*			
Flow	N	N	1020 hrs. Small area behind sandbags of standing
Erosion	N	N	water.
Outfall			
water surface El. (top of stoplogs to water)			1031 hrs. Standing water behind sandbags. No flow behind sandbags. 49 1/2". Standing water behind weir. Seeping into concrete weir structure.

\* See figure below.

**Additional Comments** (Note any changes observed along the embankment crest or downstream slope observed from the crest.): \* No visible flow observed, only audible below rip rap. water in road cuts.
